STEEL FIBROUS CONCRETE FOR AIRPORT
PAVEMENT APPLICATIONS

Frazier Parker, Jr.

Army Engineer Waterways Experiment Station

Federal Aviation Administration

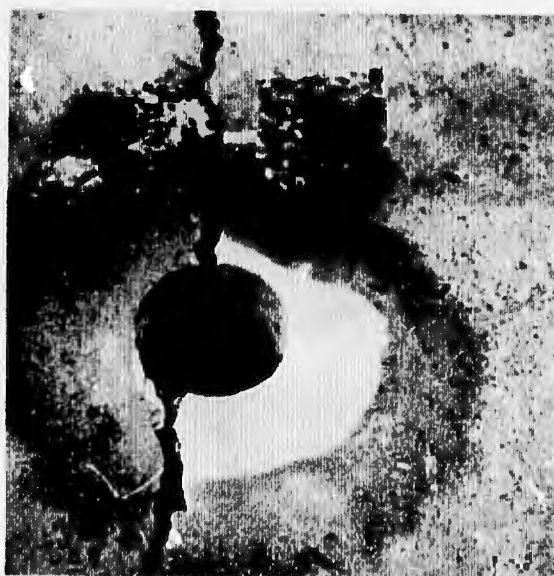
b. Core taken at a crack

Figure 12. Cores taken from a fibrous concrete slab at ORDL

When considering deterioration or corrosion of fibers at a crack, two distinct types of cracks must be considered. Cracks which occur due to shrinkage or volume change of the concrete or reflective cracks in overlays due to volume change in the base pavement constitute the first type. It has been observed that such cracks are sufficiently wide to admit water and air and that corrosion of the fibers occurs rapidly. However, the width of this type crack will be such that unbonding or breaking of the fibers across the crack will have occurred, and as a consequence, any deterioration of the fibers due to corrosion will have little if any effect on the pavement performance. In a number of the experimental pavements built thus far, insufficient or, in some cases, no joints were provided. As a result, cracks occurred which opened up rather wide and the fibers deteriorated rapidly. Figure 12b shows a core taken across such a crack which occurred in one of the slabs constructed at ORDL in 1967. The fibers across this crack were completely deteriorated.

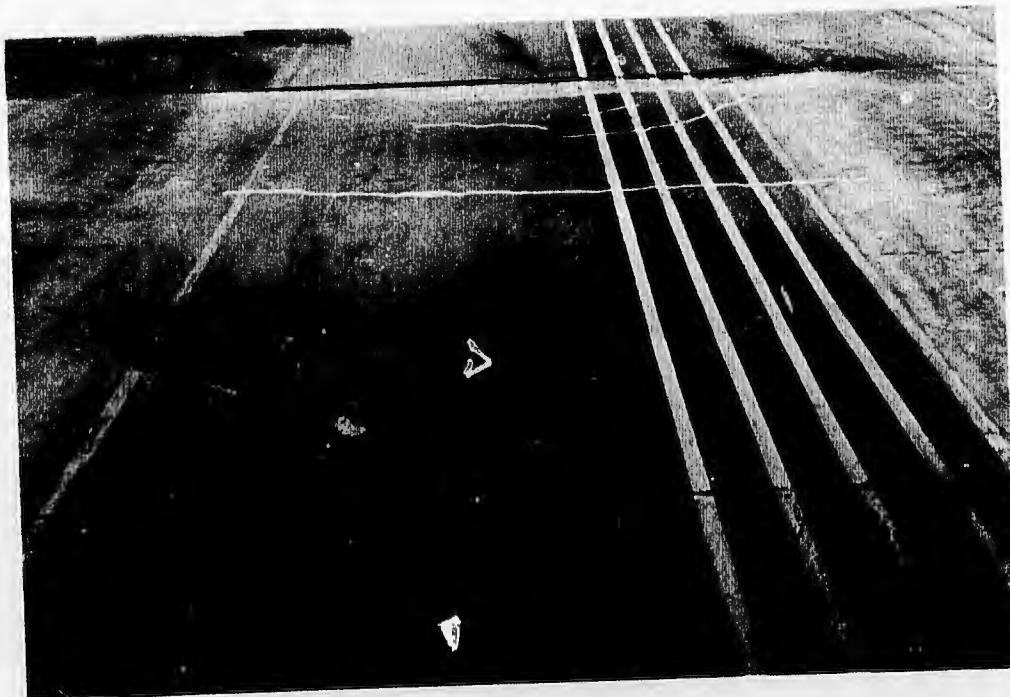
Figure 13. Early cracking of a 6-in. fibrous concrete slab on a clay subgrade

cracks or flaws within the concrete was discussed. On a macroscopic scale, the same phenomenon occurs. Figures 13 and 14 show cracked fibrous concrete slabs. From these figures, it can be seen that visible cracks are discrete and discontinuous. The cracks shown in Figure 13 probably developed because of tensile stresses in the bottom of the slab, while those shown in Figure 14 probably developed because of tensile stresses in the top of the slab. However, it should be noted that the latter cracks are also discontinuous. The formation of discontinuous cracks is contrary to the behavior of plain concrete slabs, in which cracks propagate to a free edge when they form. As traffic continues, cracks in fibrous concrete slabs will continue to propagate until a free edge or another crack is encountered.

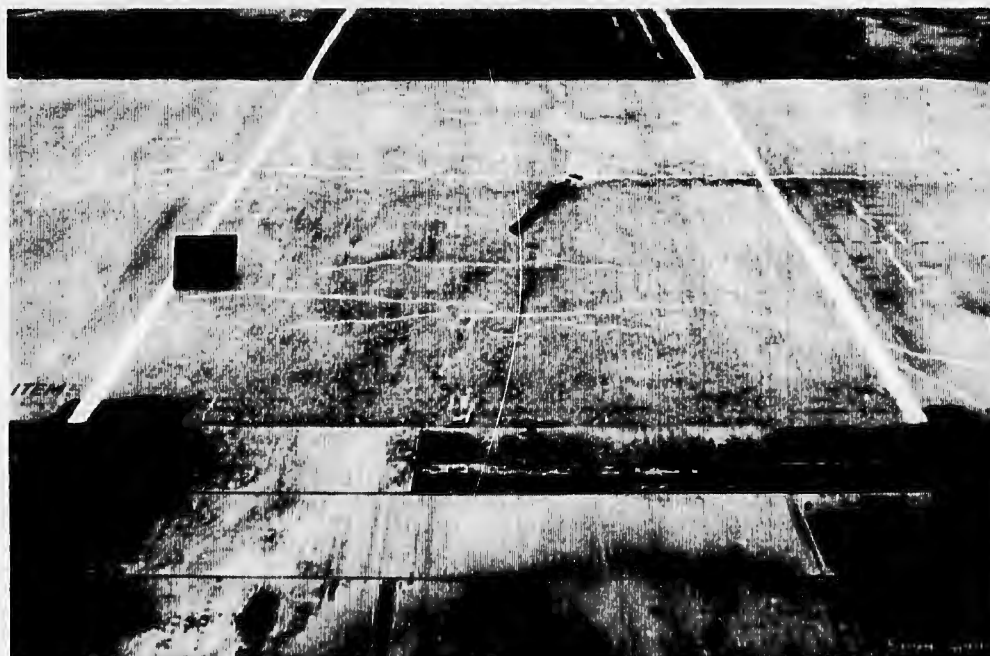
Figure 18. Fibrous concrete test pavement after 4500 coverages

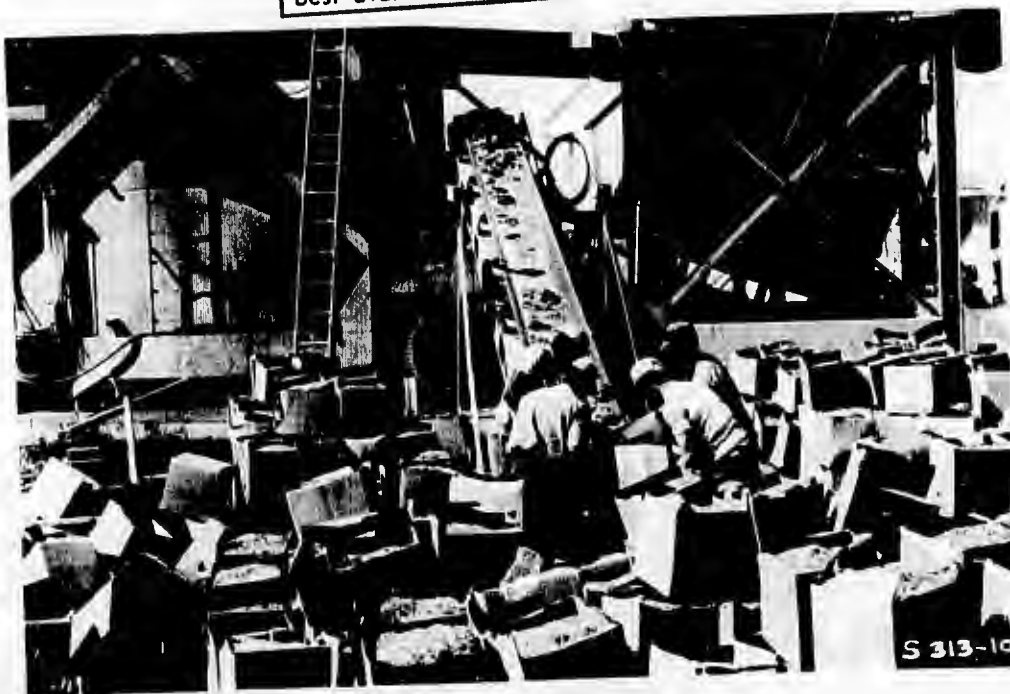
Figure 37. Emptying fibers onto a conveyor belt

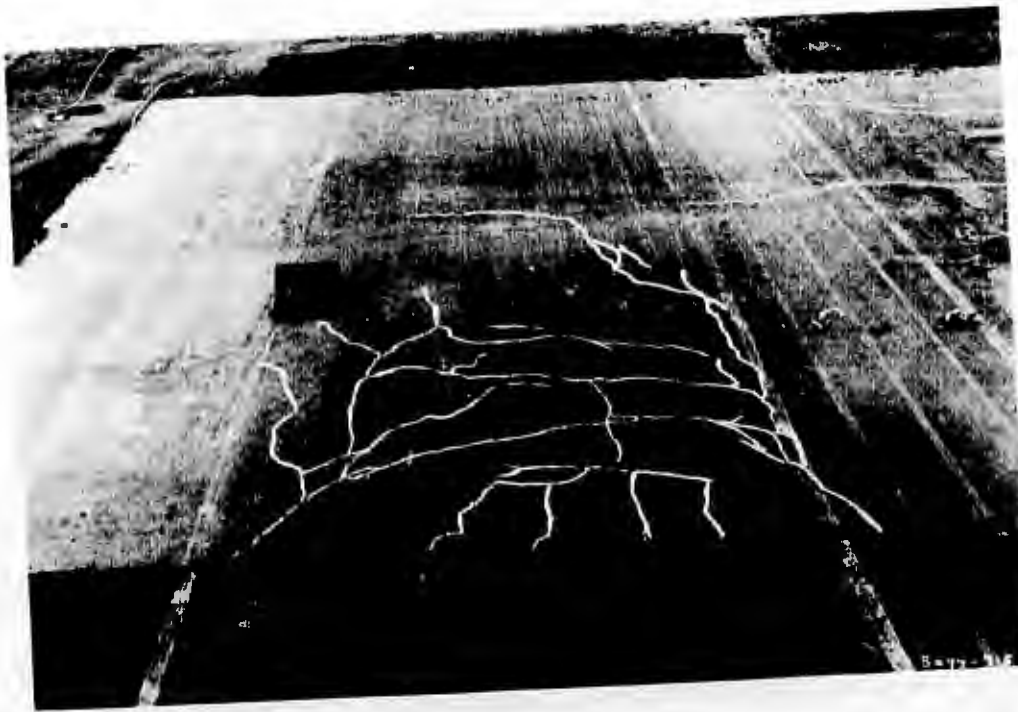
Figure 65. Item 5 after 130 coverages of
166-kip, dual-tandem assembly

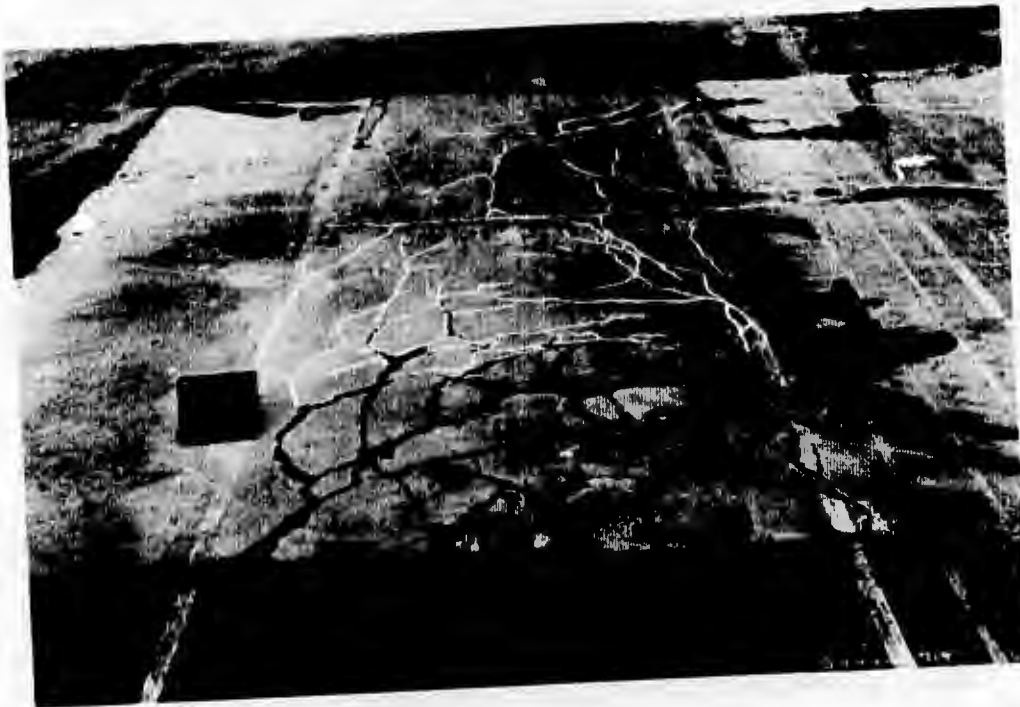
Figure 66. Item 5 after 170 coverages of
166-kip, dual-tandem assembly

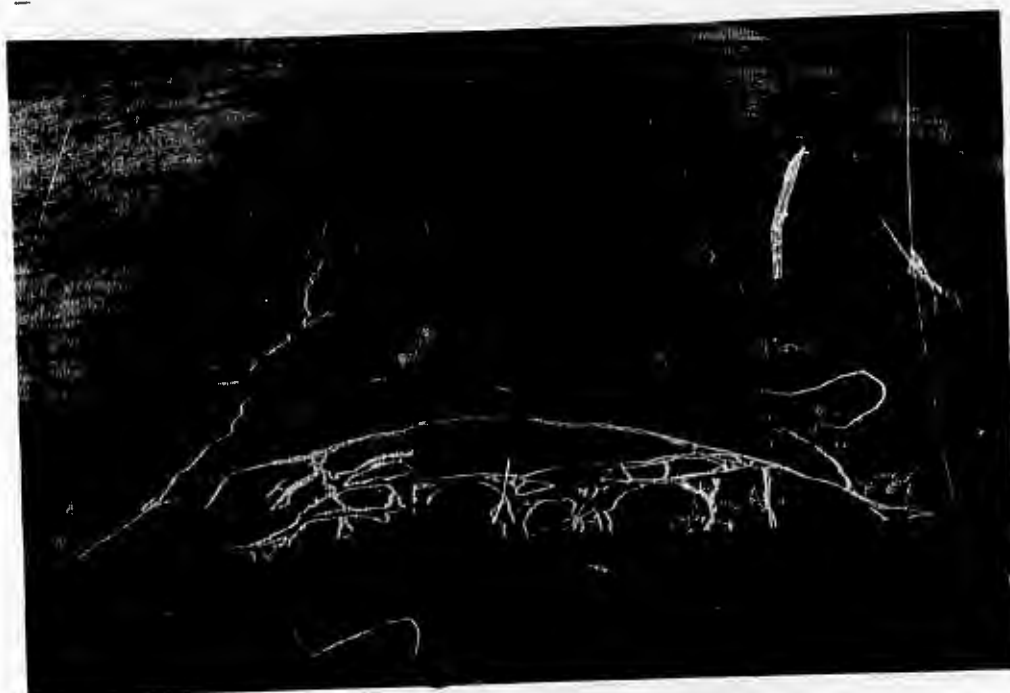
Figure 80. Item 1 after 1770 coverages of 200-kip, dual-tandem assembly

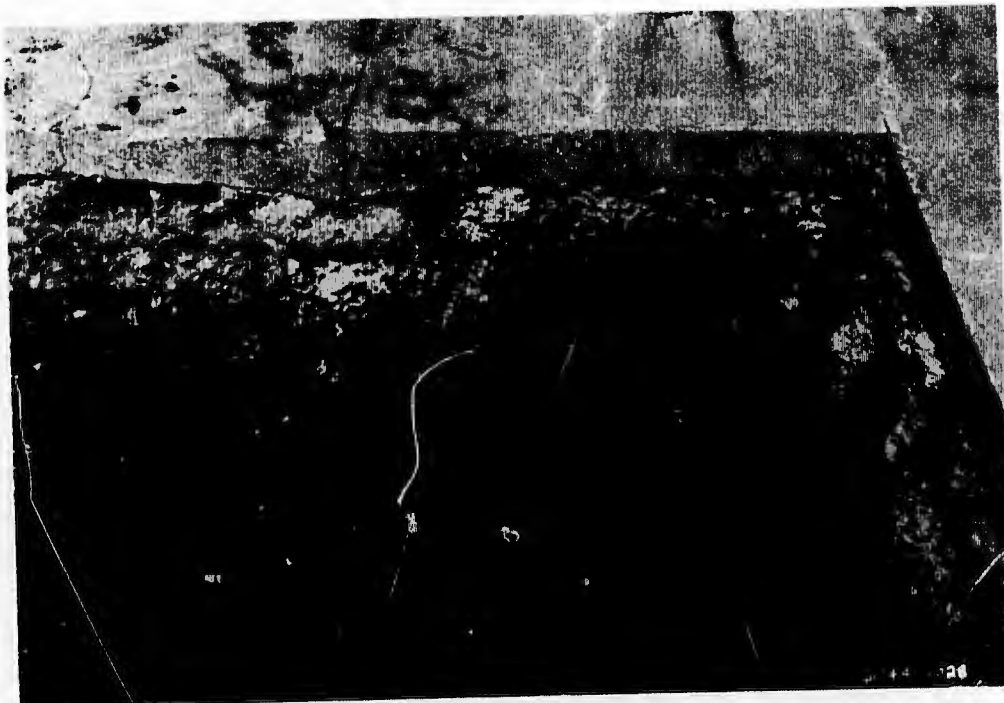
Figure 95. Test pit across longitudinal construction joint in Item 2 after 3000 coverages of 200-kip, dual-tandem assembly
